RETROFIT OF BOTTOM OUTLET NO. 1 AT THE POIANA UZULUI DAM, USING COMPLEX UNDERWATER WORKS

In order to accomplish this measure, the Siret Water Directorate, in 2017, carried out through its own investments program, a project called “Restoration of the trash rack and bell cofferdam at bottom outlet no. 1 and rehabilitation of the butterfly (safety) valve at Poiana Uzului Dam” accomplished by a design company in Bucharest

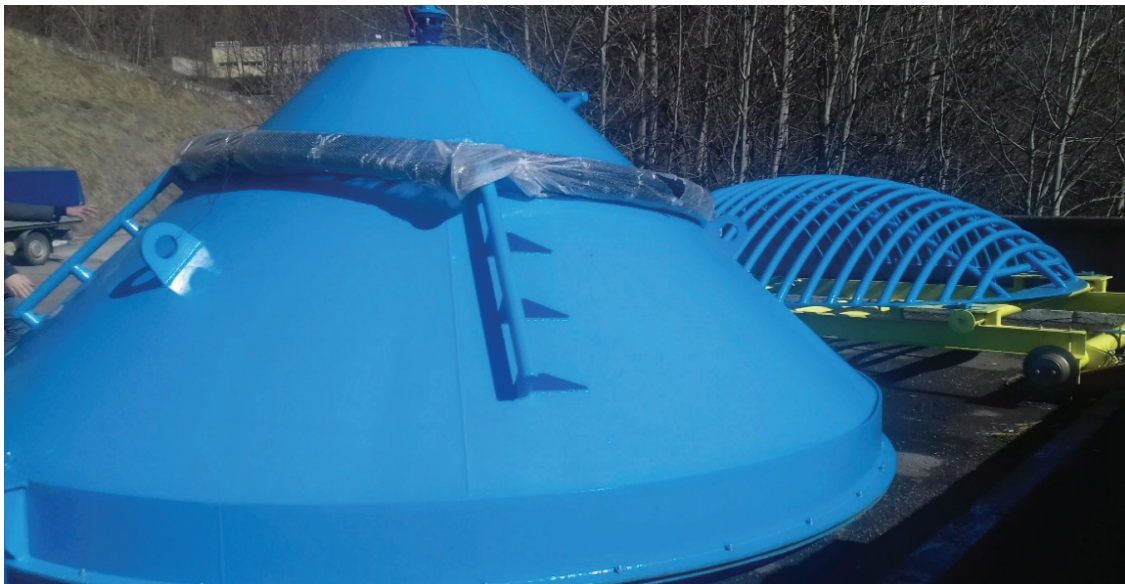
Figure 2 : The bell cofferdam and the new trash rack.

During stage I, in 2018, the pontoon, the trash rack and the bell cofferdam, the trolley for lowering the trash rack, the bell cofferdam, the pontoon and other equipment parts were built and the trolley was procured.

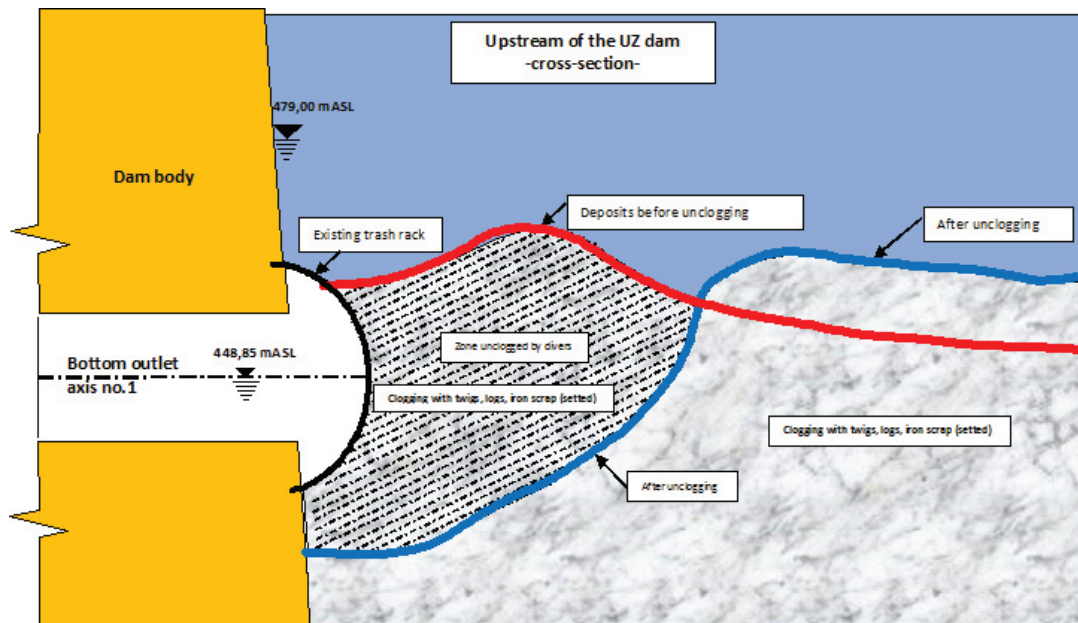
- The water level in the reservoir was lowered to 479.00 m ASL, in order to ensure safety conditions for the diving team;
- Before starting the underwater works at the bottom outlet no.1, a visual inspection of the work area was performed with the help of divers. It was found that it was 80% clogged, in front of it being blocked large logs;
- After the completion of the decommissioning works, the maneuvers were performed for extracting the old trash rack, installing the new one and fixing the bell cofferdam to dewater the bottom outlet pipe.

Figure 5 : Scheme of the necessary works for replacing the old trash rack and unclogging the entrance to the bottom outlet no. 1

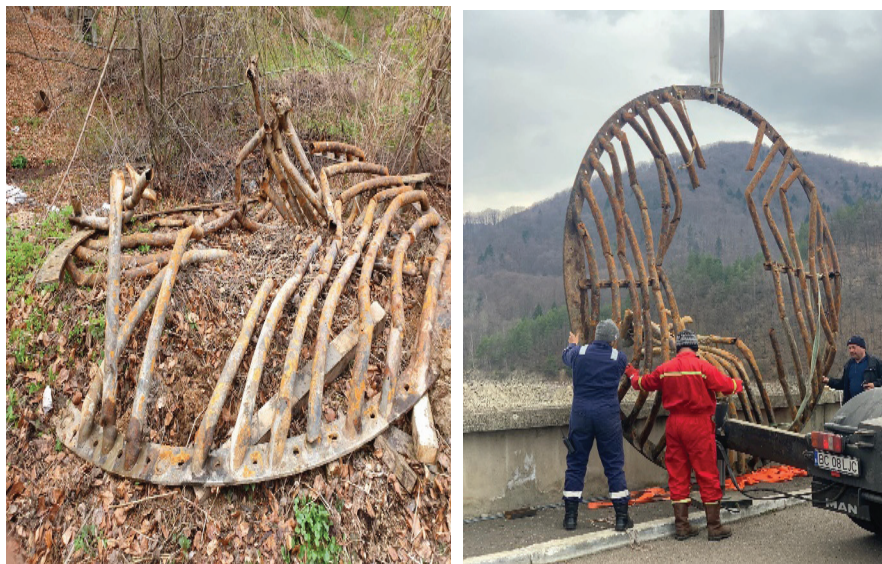
Figure 6 : Remains of the old trash rack

- In the 2018 - 2019 period the following works were carried out on the mechanical equipment of Poiana Uzului Dam:
 - (a) construction and installation of a new trash rack in front of the entrance to the bottom outlet no. 1 (from the block 19), the old one being very damaged, condition which allowed the penetration of various solid materials in the bottom outlet pipe with the risk of blocking the valves;

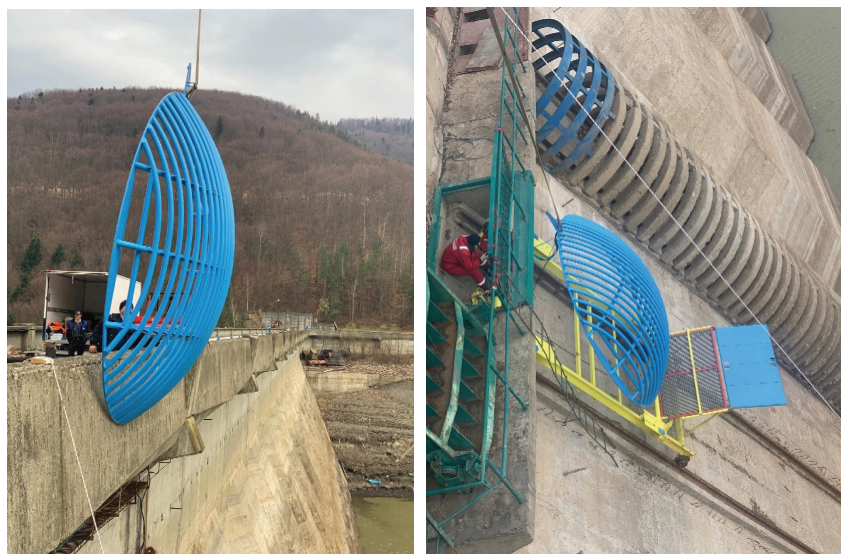
Figure. 7 : The new trash rack
